CALIFORNIA DIVISION OF MINES AND GEOLOGY
FAULT EVALUATION REPORT FER-198

GROUND CRACKS NEAR THE GARLOCK FAULT
IN SEARLES VALLEY, SAN BERNARDINO COUNTY

by
Christopher J. Wills
Associate Geologist
March 3, 1989

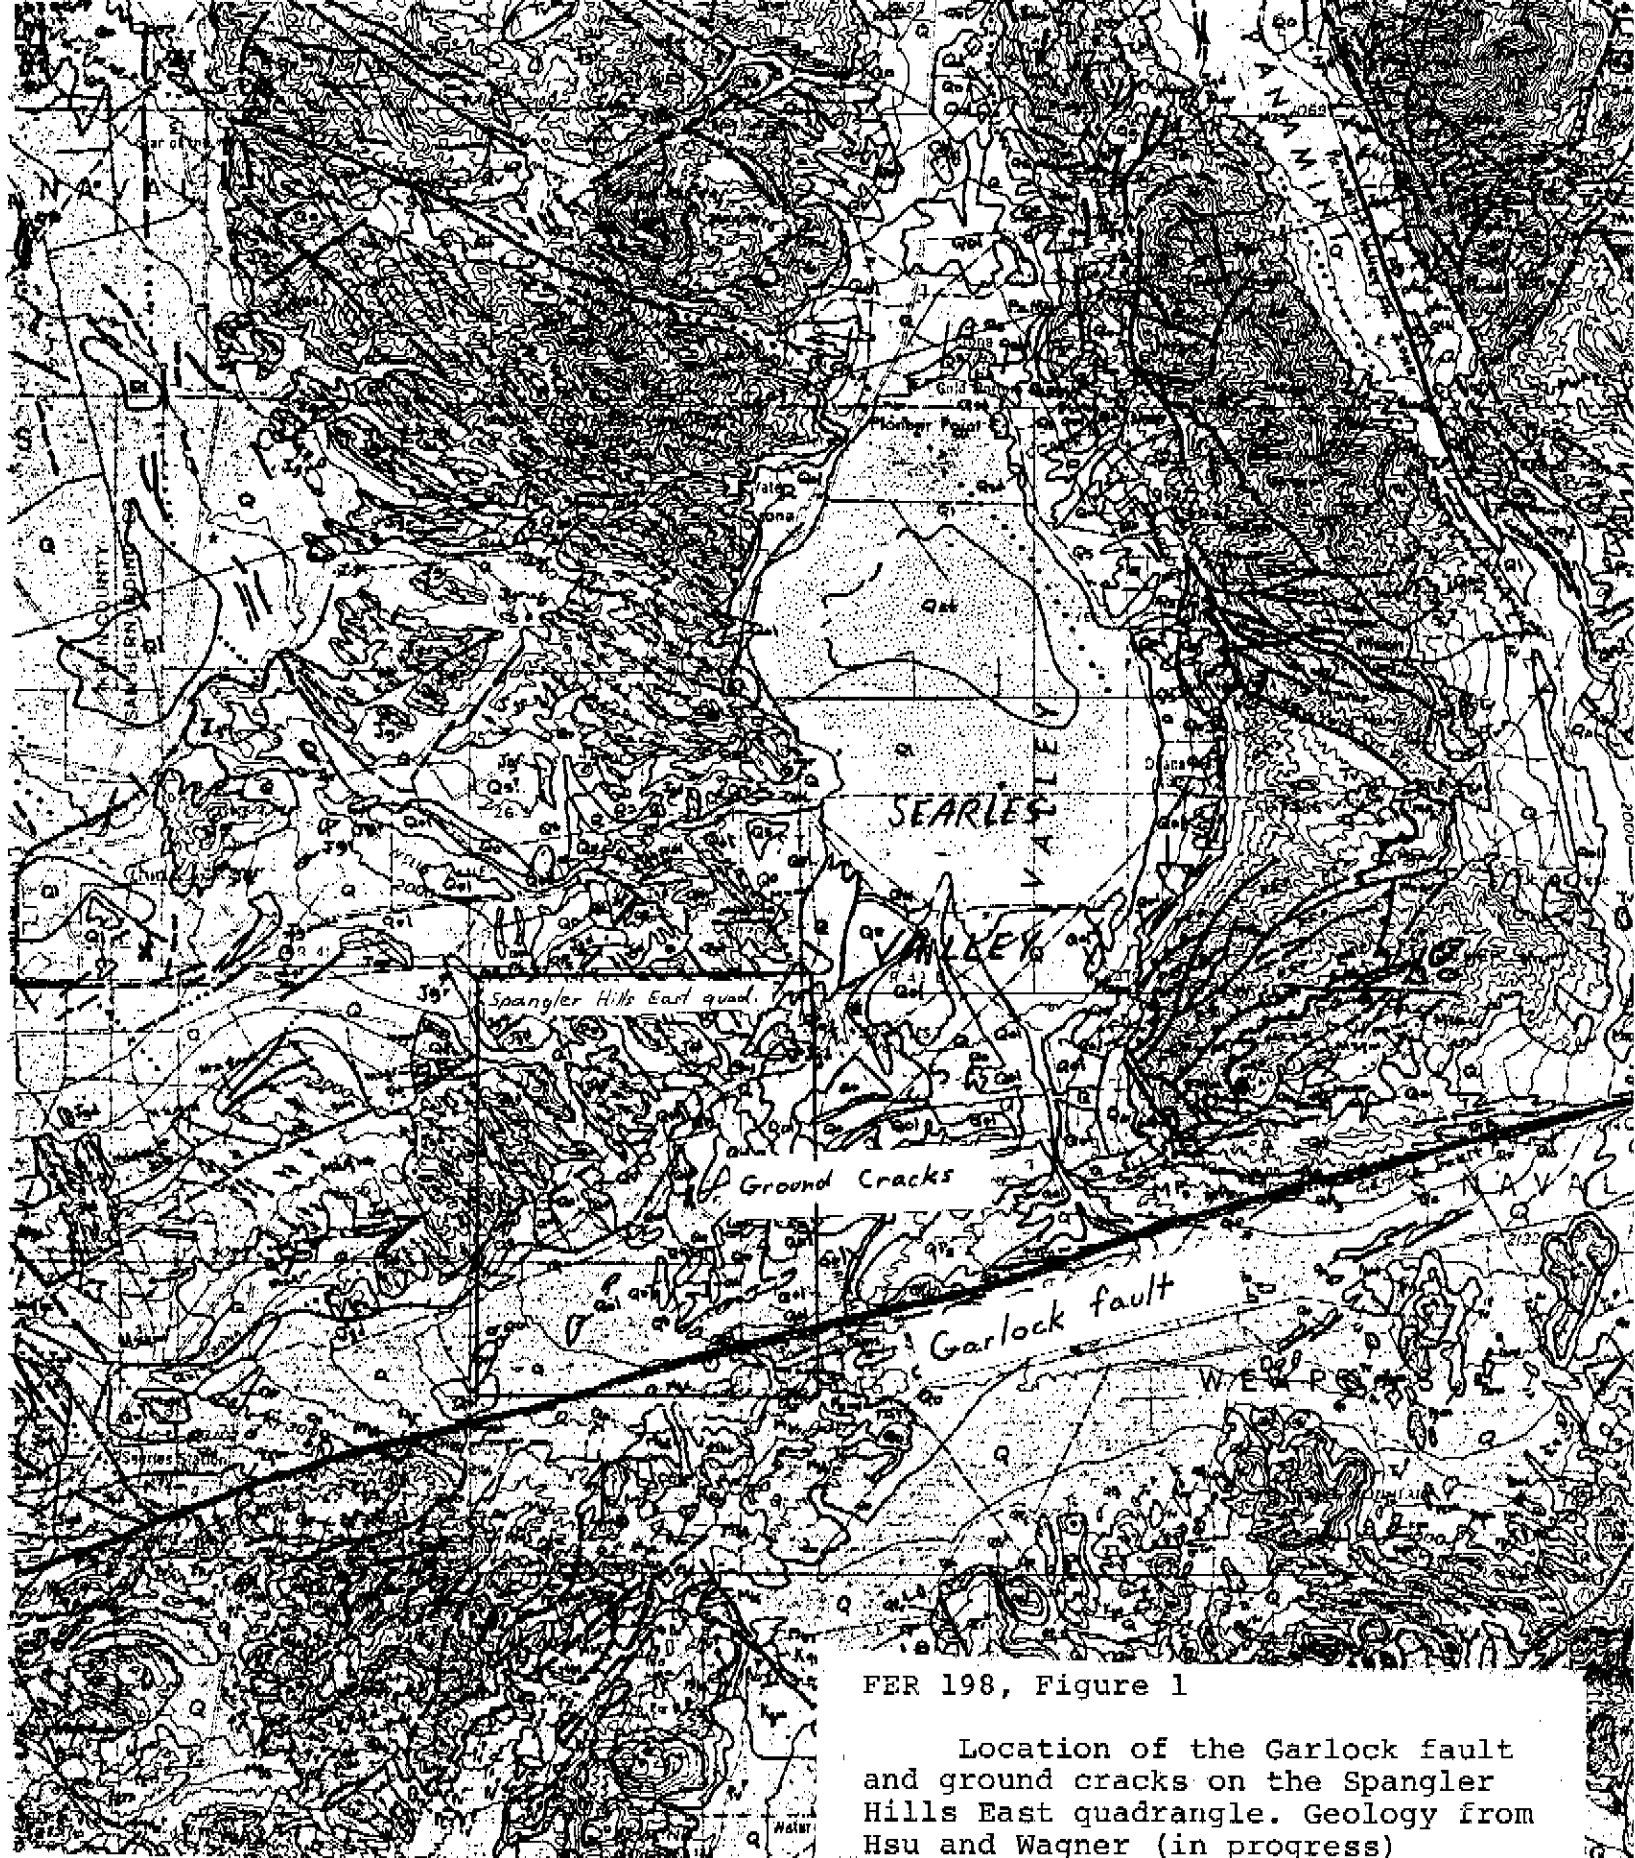
FER 198, Figure 1

Ground cracks began forming in 1970 in the Searles Valley, approximately 5 km north of the Garlock fault (Figure 1). These were originally described as extensional fissures and not thought to be related to faulting (Zellmer and others, 1985). The fissures enlarged during a thunderstorm in 1983 and a new zone of left-stepping en echelon cracks formed shortly thereafter. Zellmer and others concluded that the cracks are due to tectonic stresses associated with the Garlock fault. Because the ground cracks mapped by Zellmer and others affect the Randsburg Wash Access Road, they are evaluated here for possible zoning under the Alquist-Priolo Special Studies Zones Act.

Extensional cracks were first noticed in 1970 north of the Randsburg Wash Access Road on the China Lake Naval Weapons Center

Location of the Garlock fault and ground cracks on the Spangler Hills East quadrangle. Geology from Hsu and Wagner (in progress)
